SECTION 32 PROGRAM
STREAMBANK EROSION CONTROL
EVALUATION AND DEMONSTRATION
WORK UNIT 2 - EVALUATION OF EXISTING
BANK PROTECTION
INSPECTION OF SITES IN ALBUQUERQUE DISTRICT

Malcolm P. Keown

November 1977

Inspection Report 3

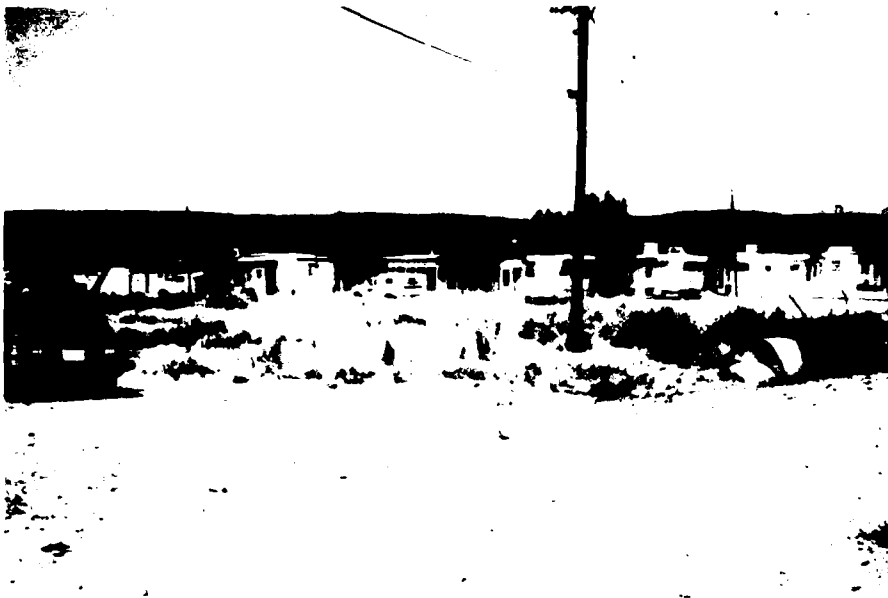
levees are constructed of native materials (sandy gravel) and are highly erosive even during low flows. Failure of the south bank levee would result in flash flooding to the low area which contains three permanent residences, 50 to 60 mobile homes, a ready-mix concrete plant, a boat storage facility, and a marine service (Figure 2).

Figure 2. Mobile home community behind south levee; access road to levee is in the right-hand portion of the photograph

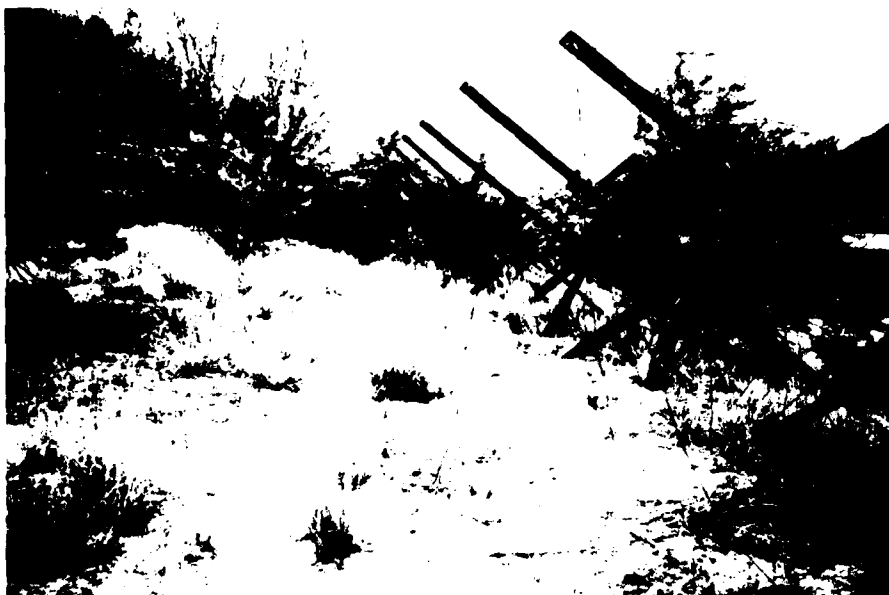
F. D. Shufflebarger, Inc. (Albuquerque) installed 4,313 lineal feet of permeable jetties (Kellner Jack Field) in 1951 (Figures 11 and 12). This installation consists of two main-line jetties (2,900 and 700 ft in length) and six backup retards varying from 133 to 265 ft in length. The jack units consist of three linear members (each being 15 ft in length) bolted together at their midpoints such that each member is perpendicular to the other two. The members are laced with #10 steel wire; the jack units are connected with cable (Figure 13). The Bureau of Indian Affairs sponsored this project at a funding level of \$24,108 (1951 dollars).

Figure 12. Section of main-line jetty

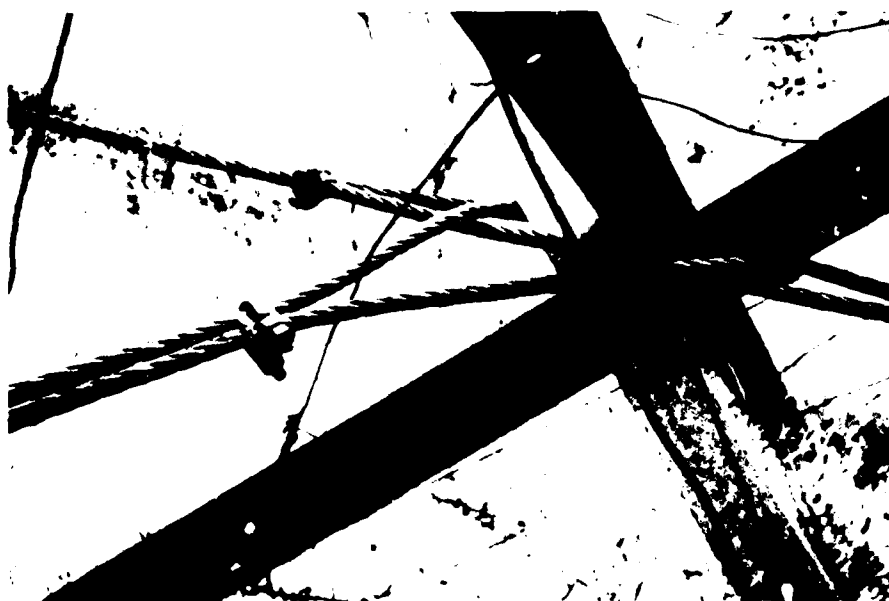
Figure 13. Jacks units are connected with steel cable; this figure shows the cable configuration at the junction of a main-line jetty and retard line

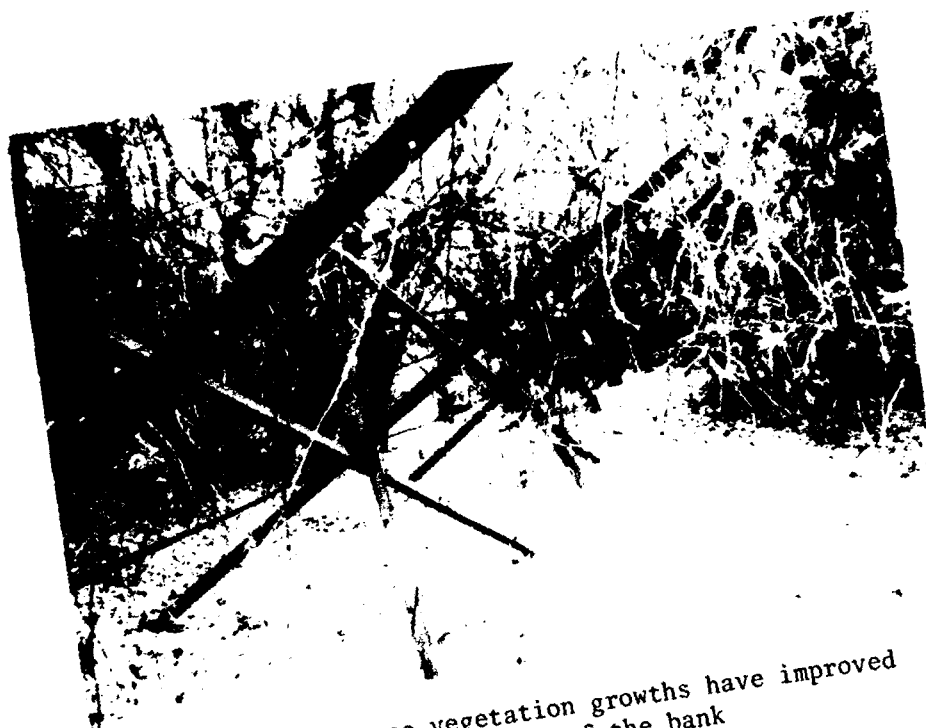
12. Inspections performed by SWA in 1955, 1956, 1958, 1960, 1963, and 1968 indicated that the project was performing its function; some of the jacks were in poor condition at the time of the 1968 inspection. Considerable sediment deposition had occurred, providing a substrate for dense growths of willow, Russian olive, and underbrush that have measurably improved the stability of the bank (Figure 14).

Figure 14. Dense vegetation growths have improved the stability of the bank

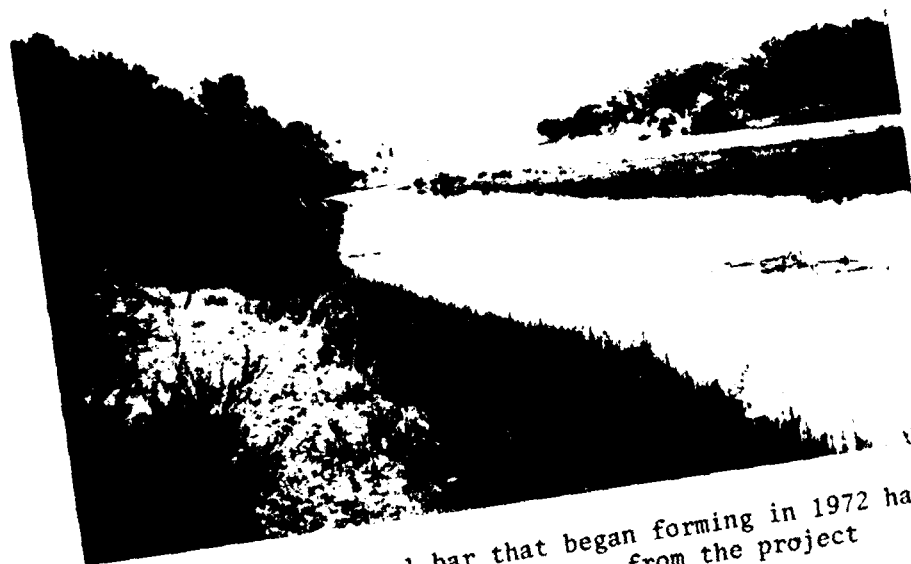
13. Six new jacks were required in 1969 as a repair measure. Beginning in 1972, a gravel bar began to build up in front of the project which has served to direct the flow away from the Kellner Jack Field (Figures 15 and 16). The last inspection, conducted in November 1976, indicated that the project has been effective in preventing further bank erosion and has encouraged sediment deposition and general restoration of the eroded bank. A project file including the inspection reports is available at the SWA office.

Figure 15. A gravel bar that began forming in 1972 has directed the streamflow away from the project
